**Flood Control Project Maintenance
Levee Inspections**
LMA District Cover Sheet
Spring 2018 Levee Inspection Results

Levee District No. 0009 (Sutter County)

Spring 2018 Levee Inspection Results

Waterway			Bank	Unit Miles
Unit No. 01 Sutter County, Feather River			Right	6.25
	Spring (March - May)	Summer (June - August)	(September - November) Fall	Winter (December - February)
Unit Maintenance Rating (Fall Only)				
Date of Inspection	3/13/2018 - 3/13/2018			
DWR Inspector	Sterling York			
Accompanied By	David Schmidl

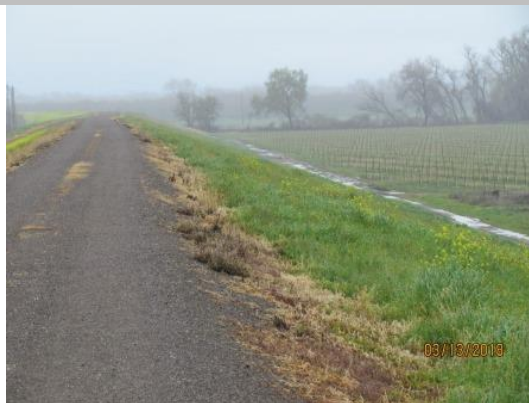
Photo 1 of 3 : SP_2018_LD0009_202_1_20180319_00009.jpg

LM Start	0.00	Rating **	A	Issue No.	1
LM End	6.24	Issue Type +	Ma	Location *	WS
Category	Earthen Levee			GPS Latitude/Longitude	
				Start	End
Item	Vegetation			39.168814 °	39.255710 °
				-121.622542 °	-121.636382 °
DWR ID	DWR_LD0009_01_s_2018_1				
Comment Code					
V1 : Control annual grass and weeds on the levee slopes and easements.					
Inspector Comment					
Annual Vegetation is well maintained, Spring 2018.

View looking upstream waterside of the well maintained annual vegetation at Levee Mile 0.28, Spring 2018.

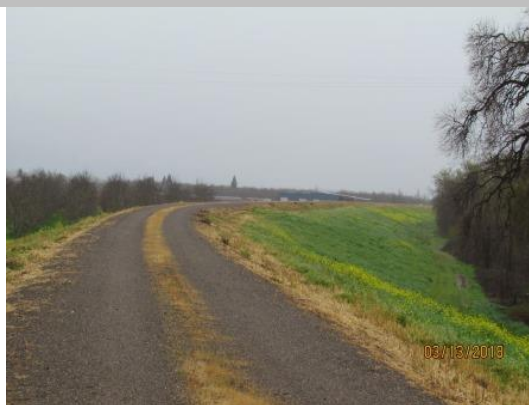
Photo 2 of 3 : SP_2018_LD0009_202_1_20180319_00010.jpg

View looking upstream waterside of the well maintained annual vegetation at Levee Mile 2.74, Spring 2018.

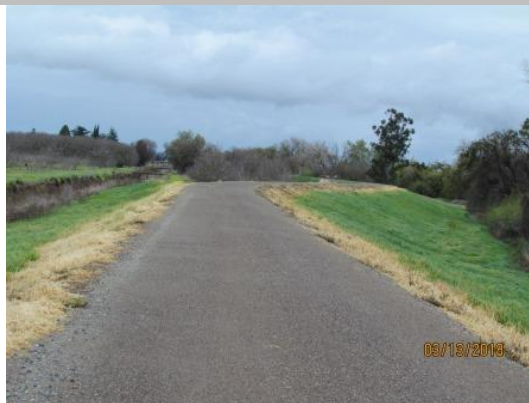
Photo 3 of 3 : SP_2018_LD0009_202_1_20180319_00011.jpg

View looking upstream waterside of the well maintained annual vegetation at Levee Mile 5.96, Spring 2018.

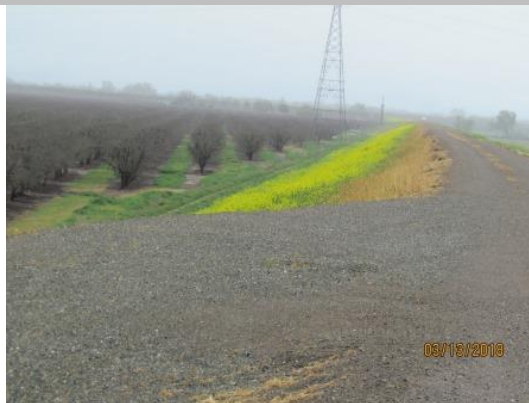
Photo 1 of 3 : SP_2018_LD0009_202_2_20180319_00006.jpg

LM Start	0.00	Rating **	A	Issue No.	2
LM End	6.24	Issue Type +	Ma	Location *	LS
Category	Earthen Levee			GPS Latitude/Longitude	
				Start	End
Item	Vegetation			39.168814 °	39.255710 °
				-121.622542 °	-121.636383 °
DWR ID	DWR_LD0009_01_s_2018_2				
Comment Code					
V1 : Control annual grass and weeds on the levee slopes and easements.					
Inspector Comment					
Annual Vegetation is well maintained, Spring 2018.

View looking upstream landside of the well maintained annual vegetation at Levee Mile 0.56, Spring 2018.

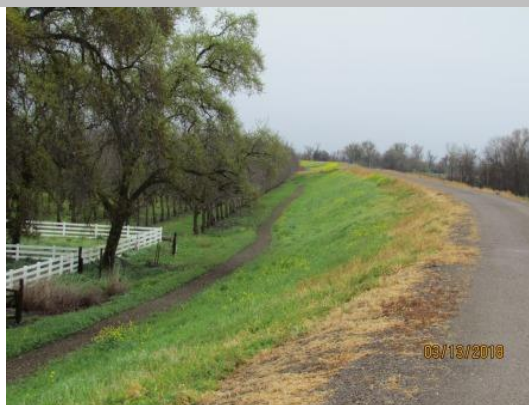
Photo 2 of 3 : SP_2018_LD0009_202_2_20180319_00007.jpg

View looking upstream landside of the well maintained annual vegetation at Levee Mile 3.14, Spring 2018.

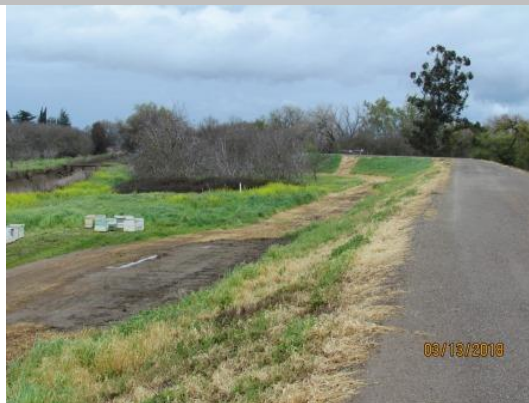
Photo 3 of 3 : SP_2018_LD0009_202_2_20180319_00008.jpg

View looking upstream landside of the well maintained annual vegetation at Levee Mile 5.96, Spring 2018.

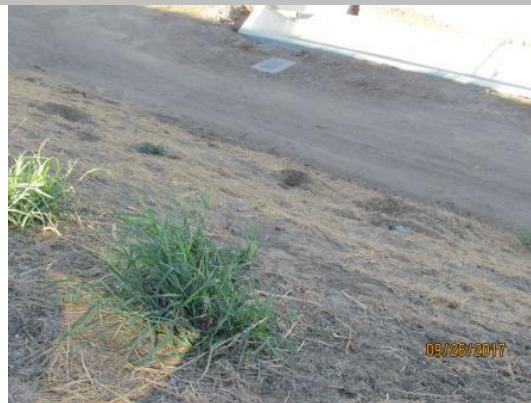
Photo 1 of 1 : SP_2018_LD0009_202_18_20180302_00003.jpg

LM Start	0.09	Rating **	M	Issue No.	18
LM End	0.09	Issue Type +	Ma	Location *	LS
Category	Earthen Levee			GPS Latitude/Longitude	
				Start	End
Item	Animal Control			39.170064 °	39.170064 °
				-121.622563 °	-121.622563 °
DWR ID	DWR_LD0009_01_f_2016_18				
Comment Code					
A3 : No rodents visible, but rodent burrows visible; need to backfill and compact or grout burrows.					
Inspector Comment					
Rodent activity was observed, holes need to be backfilled. Spring 2018.

View on landside of rodent activity and holes, Fall 2017.

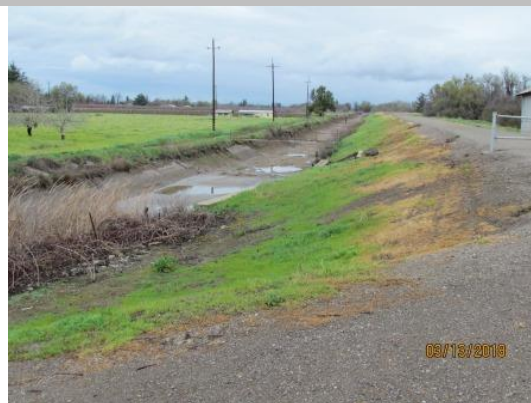
Photo 1 of 2 : SP_2018_LD0009_202_20_20180319_00012.jpg

LM Start	5.66	Rating **	M	Issue No.	20
LM End	6.00	Issue Type +	En	Location *	LS
Category	Earthen Levee			GPS Latitude/Longitude	
				Start	End
Item	Encroachments			39.247349 °	39.252258 °
				-121.637341 °	-121.637077 °
DWR ID	DWR_LD0009_01_f_2016_20				
Comment Code					
DT : Ditch					
Inspector Comment					
Ditch at the toe of the landside levee, Spring 2018.

View looking upstream of ditch at the toe of the landside levee, Spring 2018.

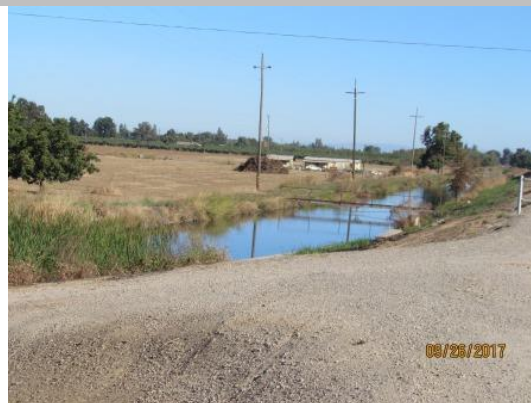
Photo 2 of 2 : SP_2018_LD0009_202_20_20180302_00004.jpg

View of ditch at the toe of the landside, looking upstream, Fall 2017.

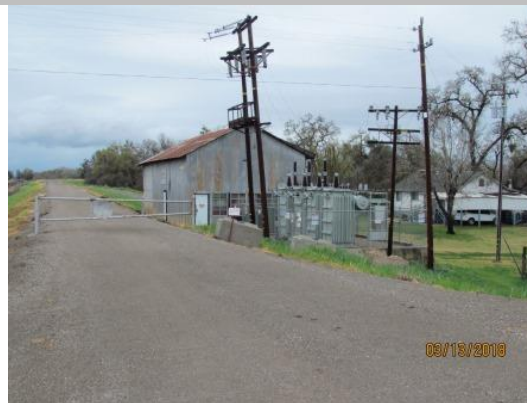
Photo 1 of 2 : SP_2018_LD0009_202_11_20180319_00013.jpg

LM Start	5.68	Rating **	A	Issue No.	11
LM End	5.68	Issue Type +	En	Location *	WS
Category	Earthen Levee			GPS Latitude/Longitude	
				Start	End
Item	Encroachments			39.247697 °	39.247697 °
				-121.637312 °	-121.637312 °
DWR ID	DWR_LD0009_01_s_2012_11				
Comment Code					
BU : Building					
Inspector Comment					
Building and Pumping equipment at the waterside toe is permitted under Permit No. 3610, Spring 2018.

View looking upstream waterside of a building and Pumping equipment at the waterside toe is permitted under Permit No. 3610, Spring 2018.

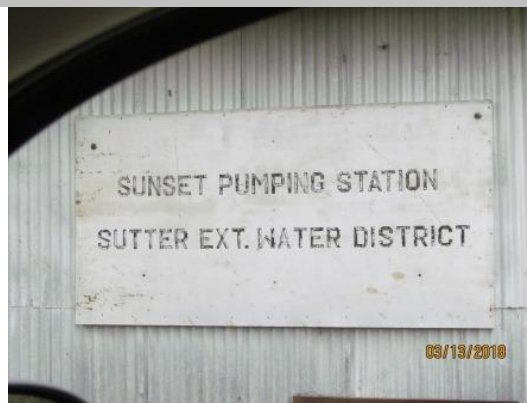
Photo 2 of 2 : SP_2018_LD0009_202_11_20180319_00014.jpg

Building and Pumping equipment at the waterside toe is permitted under Permit No. 3610, Spring 2018.
